# Variability in the interpretation of information in the investigation of road traffic incidents using 3D scanning devices

**Annotation. Problem.** One of the key challenges in the investigation of road traffic accidents (RTAs) is the reliable determination of the collision mechanism between vehicles, especially in cases where the vehicles have been moved from the scene. Traditional methods of documentation and analysis often lack sufficient accuracy and objectivity. **Goal.** The aim of this study is to identify the mechanism of collision between two vehicles by analyzing and comparing their geometric damage patterns obtained via 3D scanning, followed by determining their actual relative positioning at the moment of initial contact. **Methodology.** To achieve this goal, a portable 3D scanner Artec Leo was used, enabling high-precision scanning of vehicles regardless of their location. The resulting 3D models of the damaged vehicles were aligned with each other and with a digital version of the accident scene diagram. During the analysis, vehicle orientation angles, the location of primary contact, movement directions, and damage characteristics were determined. **Results.** It

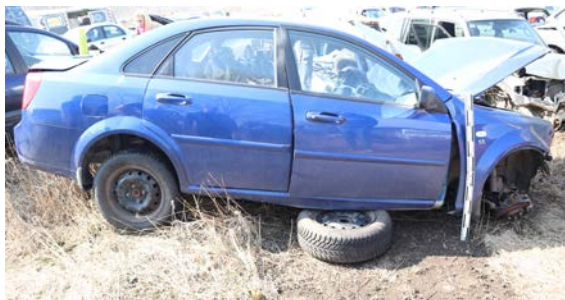
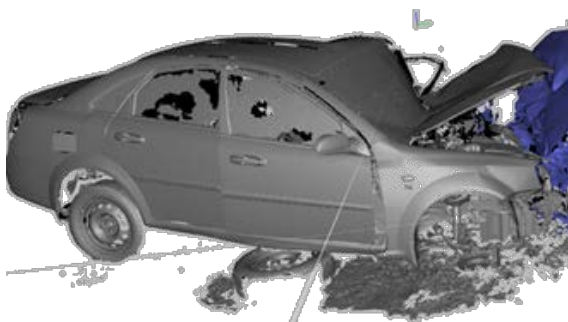
Fig. 1. Damaged passenger vehicle 1: a – photograph of the vehicle's condition; 2 – 3D spatial field corresponding to the visual condition of damaged vehicle 1

The comparison of 3D scanning results of the damaged vehicles (see Fig. 1a and b, as well as Fig. 2a and b) demonstrates that they accurately reflect the actual deformation sustained by the vehicles as a result of the frontal collision during the road traffic accident. Therefore, the further use of the 3D spatial field is objective and can be reliably employed in subsequent investigations to clarify the circumstances of the accident.

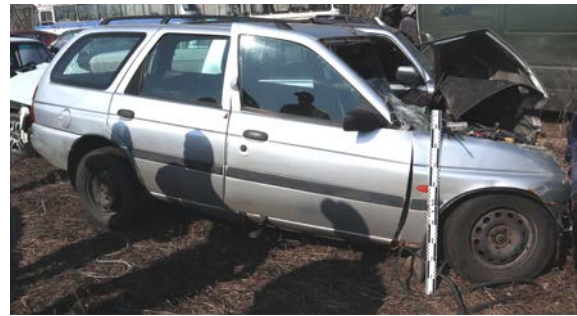
Fig. 2. Damaged passenger vehicle 2: a – photograph of the vehicle's condition; 2 – 3D spatial field corresponding to the visual condition of damaged vehicle 2

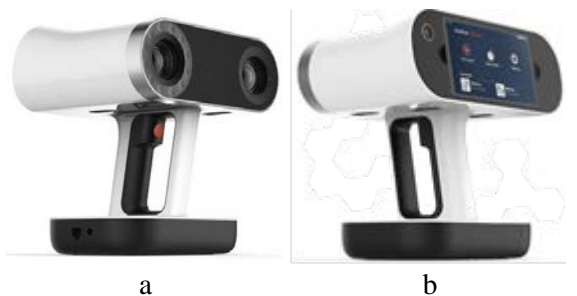
Fig. 3. Artec Leo 3D scanner: a – front view of the scanner; b – rear view of the scanner

To obtain the 3D spatial field of the damaged vehicles in this study, the “Artec Leo 3D scanner” device was used (Figure 3), which has the following technical specifications (Table 1).

The Artec Leo scanner is equally capable of capturing both large areas and the finest surface details or elements. When used at the scene of a road traffic accident, as opposed to being used at an impound lot, it significantly increases the amount of information available for automotive technical examination by recording small details scattered on the roadway or shoulder in the area where the vehicles involved in the accident were located.
